Low valued energy sources UPgrading for buildings and industry uses

LowUP Operation and Validation results for Relevant environment 1 (industrial-upgrading solution)

Deliverable D4.15

Lead Beneficiary: ACCIONA December/2020

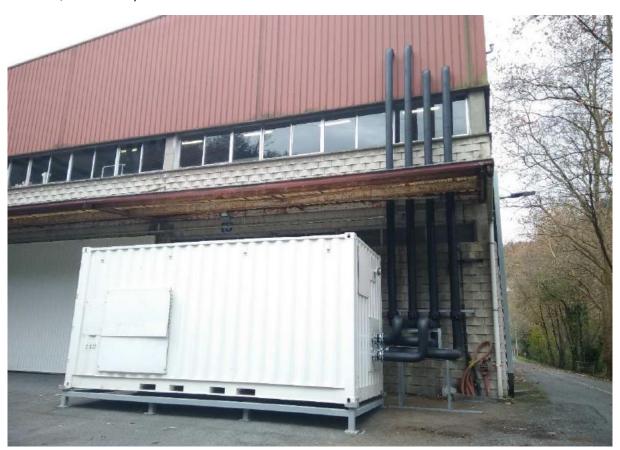
Figure 1: Containerized HP solution during testing at Tecnalia Lab

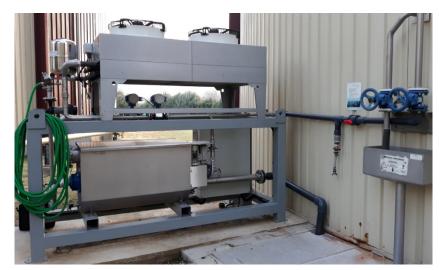
Figure 2 and Figure 3. Image of heat exchanger, installed in the pilot of Madrid (front view).

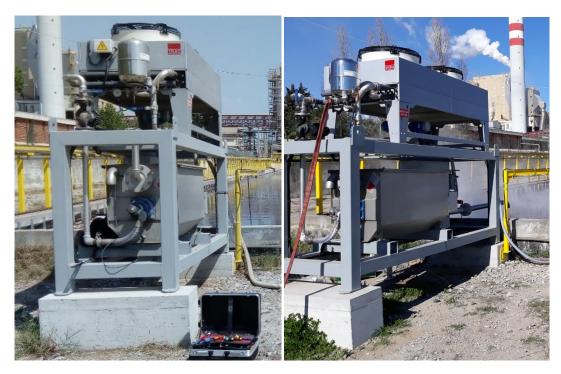
Figure 4. Heat recovery system and auxiliary systems after their installation in Setubal.

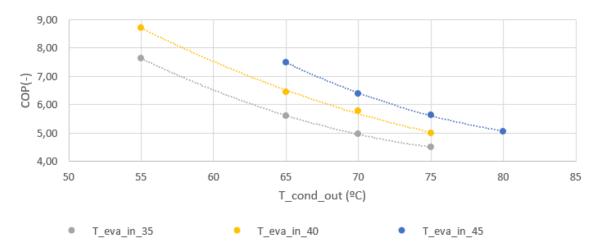
- Horizontal axis outlet temperature from HP condenser (which is the setpoint for this equipment)
- Vertical axis COP achieved with monitoring during operation

Achieved slopes have different color as function of inlet temperature at evaporator.

Figure 5: Evaporation slopes with CONDENSER at 100% of capacity

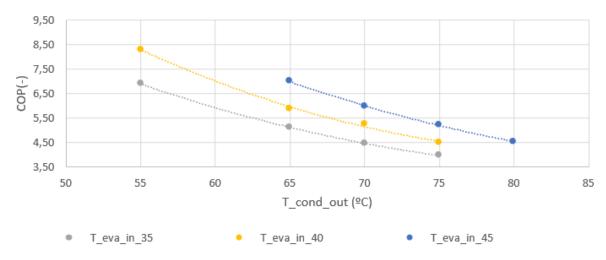
Figure 6: Evaporation slopes with EVAPORATOR at 100% of capacity

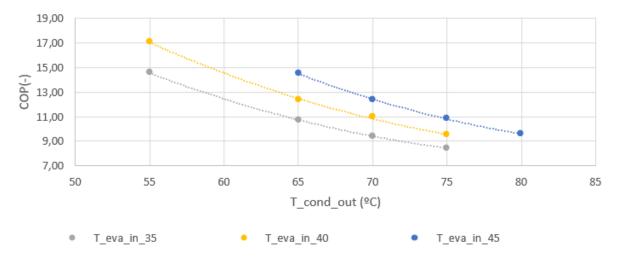
Figure 7: Evaporation slopes with COMBINED 100% of capacity

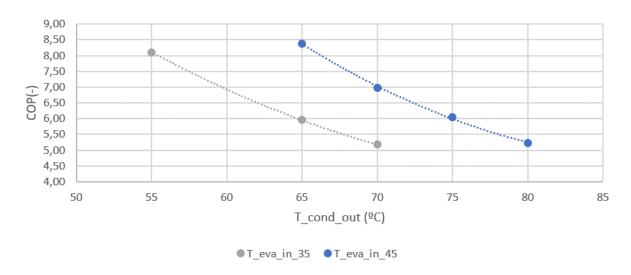
Figure 8: Evaporation slopes with CONDENSER at 50% of capacity

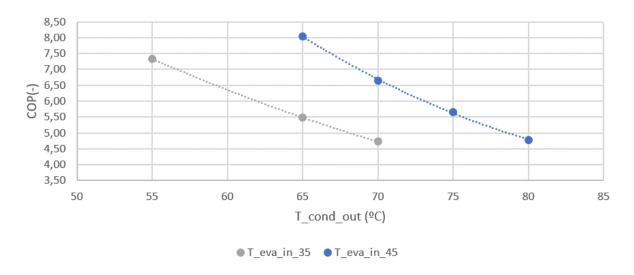
Figure 9: Evaporation slopes with EVAPORATOR at 50% of capacity

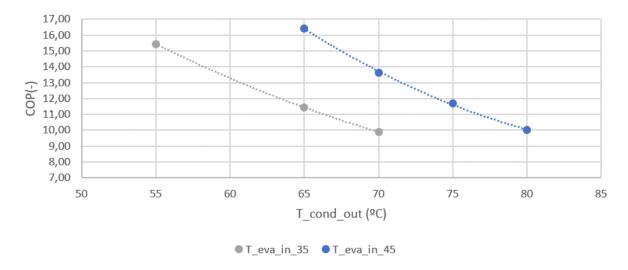
Figure 10: Evaporation slopes with COMBINED 50% of capacity

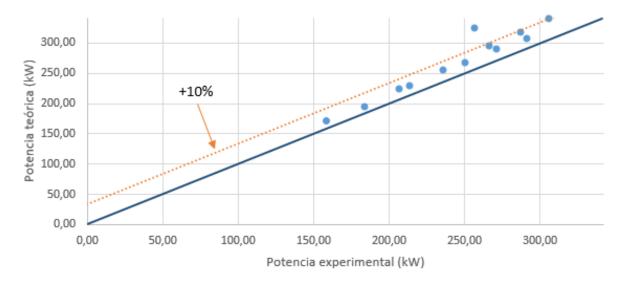
In order to simplify interpretation of graphic, in blue is represented theoretical performance slope, while in orange is represented the same slope of performance but with difference of 10% with respect to blue one. Blue dots represent real position of performance achieved during tests.

- · Horizontal axil theoretical power (kW)
- Vertical axis monitored power (kW)

Figure 11: Comparison between theoretical and real delivered power at 100% CONDENSER capacity

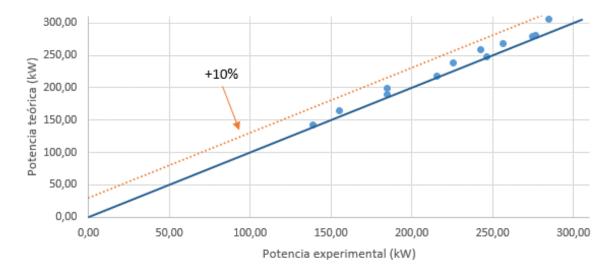
Figure 12: Comparison between theoretical and real delivered power at 100% EVAPORATOR capacity

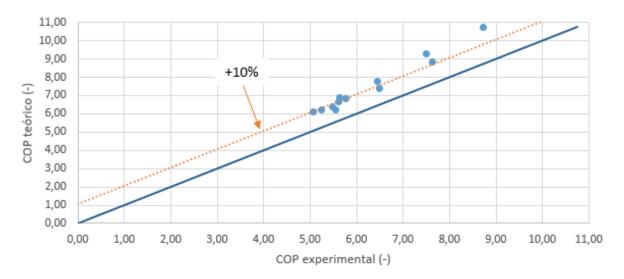
Next graphic reports difference of real COP with respect to design software:

- Horizontal axil theoretical COP
- Vertical axis monitored COP

Figure 13: Comparison between theoretical and real delivered COP at 100% CONDENSER capacity

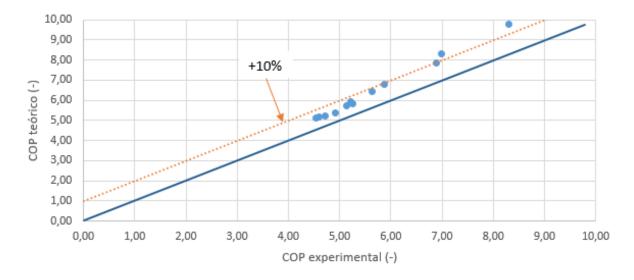
Figure 14: Comparison between theoretical and real delivered COP at 100% EVAPORATOR capacity

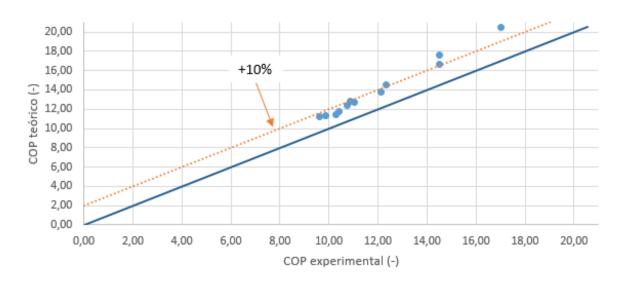
Figure 15: Comparison between theoretical and real delivered COP at 100% COMBINED capacity

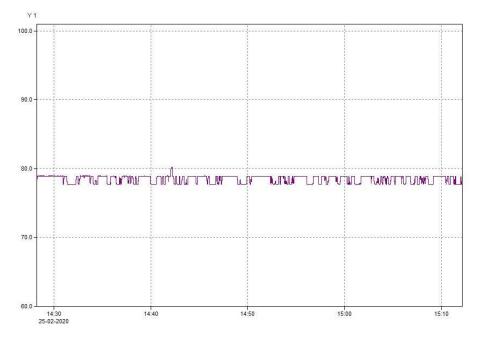
Flowing charts show difference in expansion valve regulation control for Mass-flow and PI.

Figure 16: Valve opening with PI control

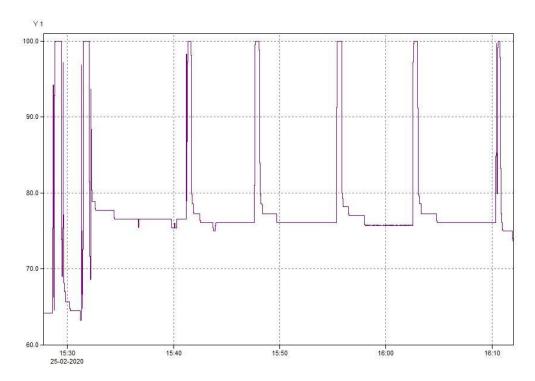
Figure 17: Valve opening with Mass-flow control

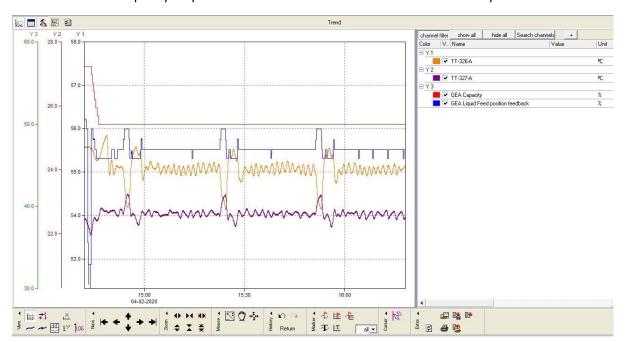
At 50% of capacity - operation conditions were condenser 55°C and evaporator 25°C

Figure 18: Operation 55°C_25°C_50%

In above figure, orange line represents inlet temperature from condenser, while violet is evaporator outlet temperature; blue line is opening of expansion valve, while red is compressor capacity.

It can be detected how, maintaining stable inlets at desired conditions without any other disturbing element, around each 30 min the valve has an unexplained peak of opening of 2,5%; after each peak the original position is recovered within 1 minute.

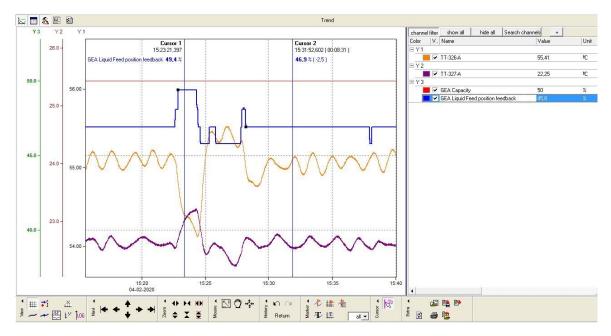
Figure 19: Opening peak for expansion valve

Due to this peak, stability is lost for outlet temperature of both evaporator and condenser. For condenser, variation is 1K of reduction, while for evaporator variation is 0,55K of increment; then original temperature is achieved again.

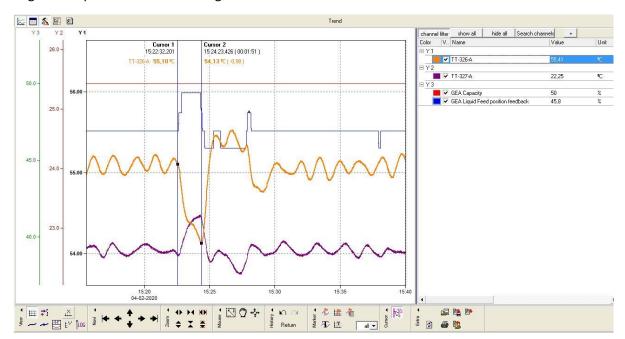
Figure 20: Effect of opening over CONDENSER

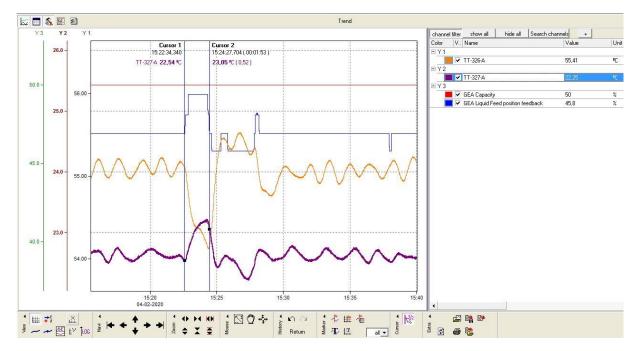
Figure 21: Effect of opening over EVAPORATOR

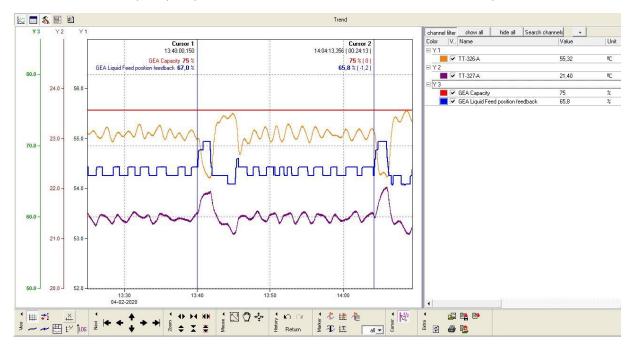
At 75% of capacity – operation conditions were condenser 55°C and evaporator 25°C

Figure 22: Operation 55°C_25°C_75%

In this case expansion valve vas regulating between 65-67%, when every 24 min aprox valve was opening 3,6%, causing reduction of outlet temperatures.

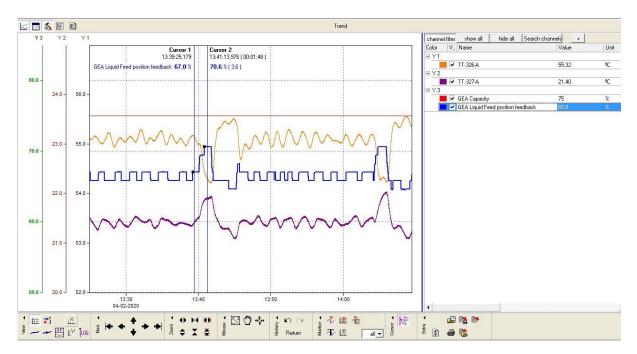
Figure 23: Peak of valve opening and temperature variation

It can be seen how condenser outlet temperature loses stability for aprox ±0,64K. Here below is explained how problem was finally solved.

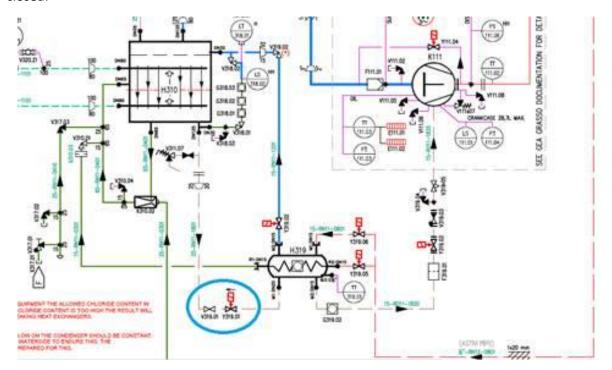
It was detected that oil recovery system was generating fluctuations; it was discovered that solenoid valve Y319.01 (blue circle) was installed the other way round; this was generating instability to evaporator during return cycle of oil to compressor.

Increase of pressure during recovery overcame valve closure resistance, allowing entrance of gas to evaporator through this line, increasing pressure inside it. To avoid this, valve Y319.01 was manually closed.

Figure 24: HP refrigerant loop P&ID

It wasn't clear if X310.03 device (red circle) had really been installed, because gas entrance to evaporator was direct during NH₃ evaporation cycle, affecting negatively on efficiency of evaporator.

Solution was achieved bypassing totally oil recovery process, deactivating actions of solenoid valve and removing its installation piping, excepting for 15-RN11-1201, which has been kept open to maintain same level pressure inside evaporation tank and evaporator, as shown in figure below.

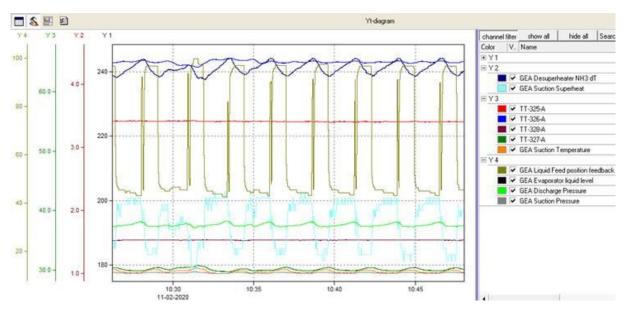
As soon as evaporation temperature was raising 40°C, liquid low level of refrigerant inside evaporator triggered; as consequence expansion valve lost stability closing between 100 to 5%. During this valve closing-phase, discharge pressure of compressor rose to 45 bars, generating high-pressure alarm and switching off safely the HP unit.

Figure 27: Unstable operation with temperature inlet temperature close to 40°C

With these conditions, no tests with 55°C outlet from condenser and 40°C incoming at evaporator were achievable because of instability of expansion valve. Solution to problem was achieved changing control mode (introduction of PI), so tests at 50, 75 and 100% were fulfilled.

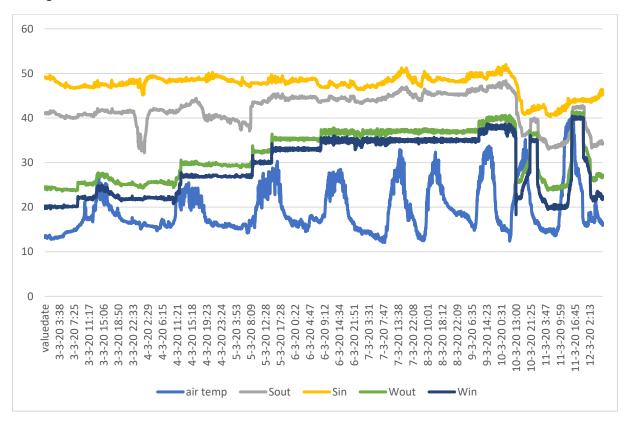
Here below is represented a typical set of test that took place during 8 consecutive days, with constant sludge and clean water flows, with different temperature setpoints for drycooler, as it can be seen through different "staircases".

Figure 28. Temperature variation of water according to programmed tests

Sludge, water and air temperature are here represented with inlet and outlet for each fluid, with HReX operating at nominal rotor speed.

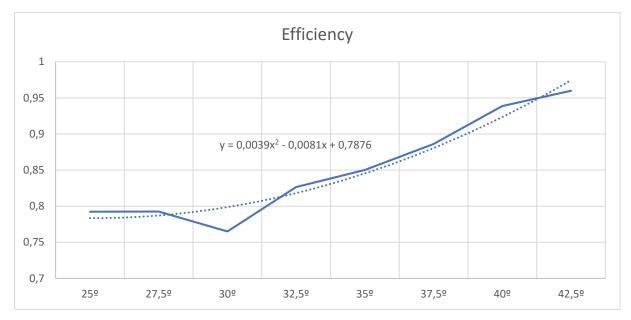
Figure 29. Variation of efficiency as function of water recovered temperature

In above picture is represented the efficiency of exchange as function of clean water outlet temperature from heat exchanger; differences are so small that little differences in decimals can change final results of efficiency.

This means that any decimal error in monitoring can affect calculation of performance. It can be evidenced how efficiency is consistent between 80 and 90%, with increasing tendency for temperature of water closer to temperature of sludge.

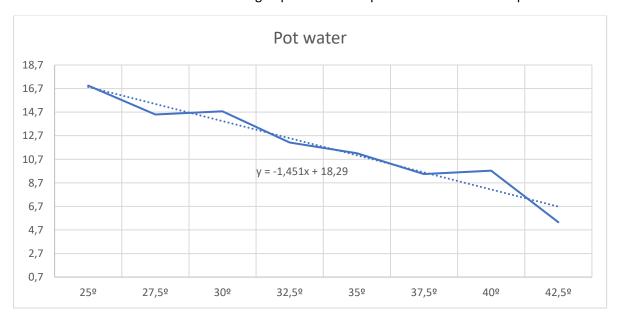
Next chart illustrates variation of exchanged power with respect to water outlet temperature.

Figure 30. Variation of exchanged power (kW) as function of water recovered temperature

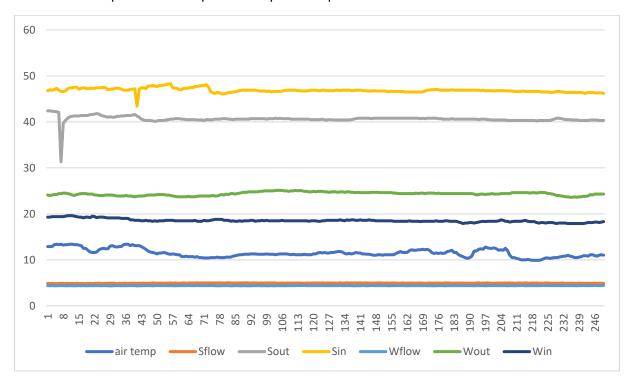
With respect to operation with sludge at 80 lt/m, it could only be achieved in stationary conditions for a relevant period at P&P, where fouling problems were not present (event happened at WWTP).

Figure 31. Stable operation at 80 lt/min at P&P factory

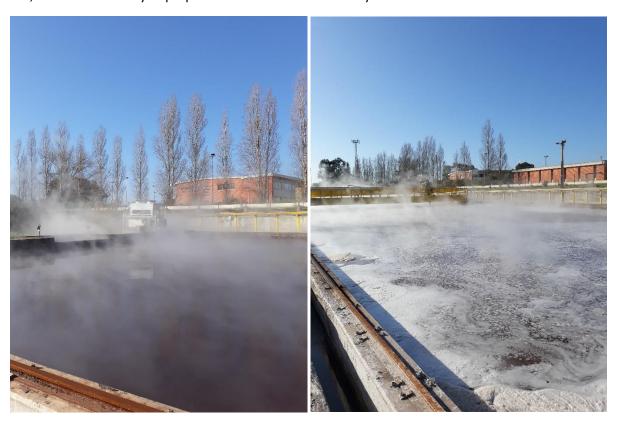
P&P factory has demonstrated to be a really aggressive environment, especially when effluent exits from the factory and arrives to local WWTP for depuration; vapor created by effluent at medium temperature (around 50°C) resulted to be corrosive for all elements not in stainless steel.

Most of time skid was downdraft with respect to decantation pool, so wind was blowing vapors toward skid, that was evidently unprepared for this kind of boundary conditions.

Figure 32. Exposure of skid to corrosive vapors of decantation pool

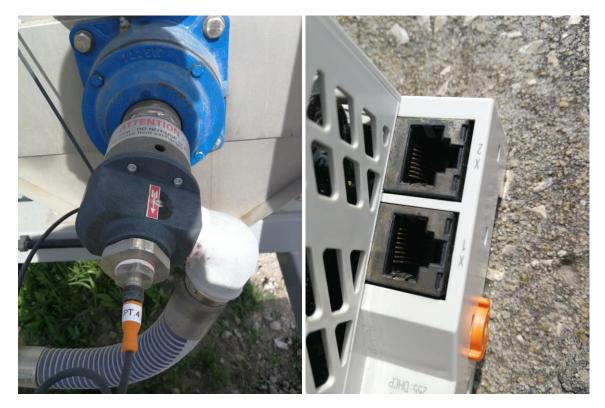
As consequence, due to prolonged exposition, the weakest elements like electronic components, sensors and copper terminals suffered problems of corrosion, which led to replacements of:

Figure 33. Replaced electronic elements for corrosion

As consequence, monitoring during period affected by corrosion was not consistent and had to be discarded. New plc and embedded pc required to be programmed and commissioned again, to verify correct communication with remote and automatic operation. At same time, electric cabinet was sealed on the bottom, where all cables enter, in order to reduce infiltration of vapors.

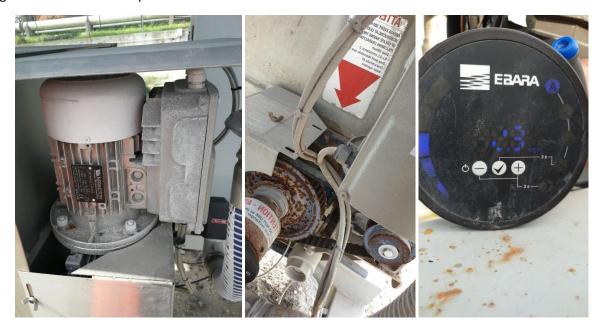
Other parts of skid were affected by exposure to aggressive element, but without compromising operation of the system, so no substitution was required. Nevertheless, thinking to extended period of time, other solution should be found to preserve the integrity of the system; the HReX is the element that presented more reliability and robustness, but auxiliary devices could suffer tremendously and generate undesired stops to installation.

Figure 34. Devices and components affected by vapor corrosion

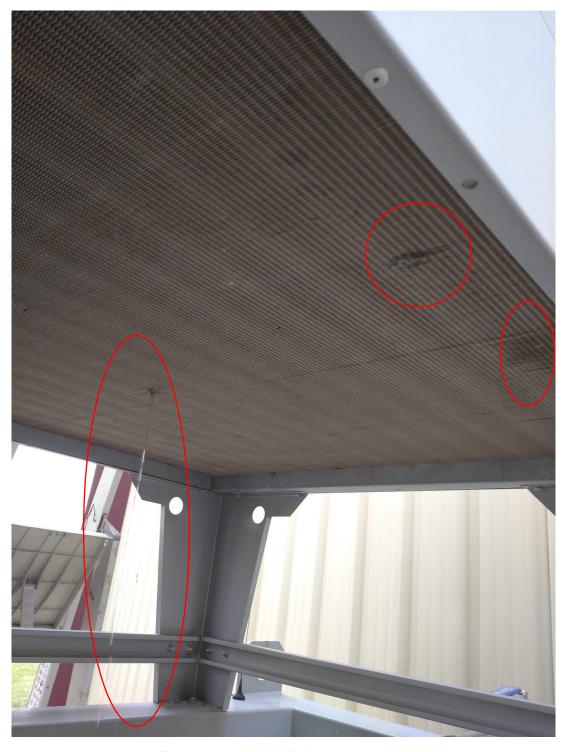
Different cause but similar results was detected in Madrid demo, where clean water loop was filled by local team with water used at WWTP for daily operation of cleaning or other activities of maintenance; this kind of water proceed from plant network that reuse depurated water taken from last pool of depuration process, so is free from suspended organic components but has not same characteristic of TAP water from network of municipality.

The result was a corrosive process that affected the coil of drycooler, creating leakages that required the entire substitution of that part of ventilating unit. In below image can be seen on of many leakages detected during filling of water loop, after replacement of water pump broken previously.

Figure 35. Leakages of drycooler water coil

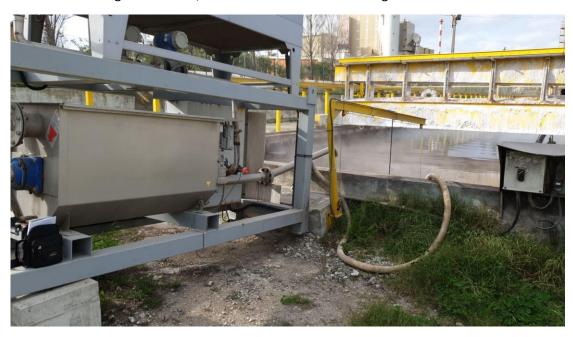
Nevertheless he skid, which was supposed to be placed properly by plant personnel, was object of collision with the bridge a first time, as it can be seen in below image.

Figure 36. Skid after collision

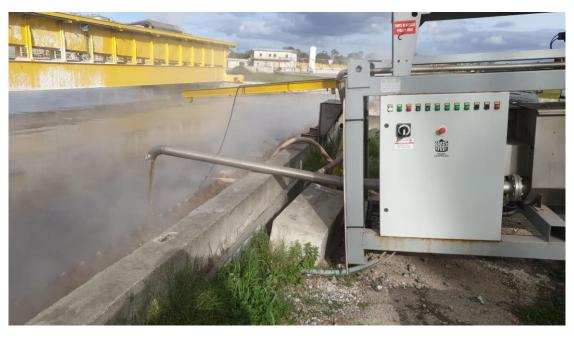
Collision caused different structural problems, but not operative; the skid dropped off from its basement, losing necessary horizontal level, while return piping and sludge pump bearing structure suffered deformations.

Figure 37. Mechanical damages of skid

The skid was relocated at requested horizontal level, by plant maintenance personnel, but moved backward with respect to initial position, in a position supposed to be safe and away from moving bridge.

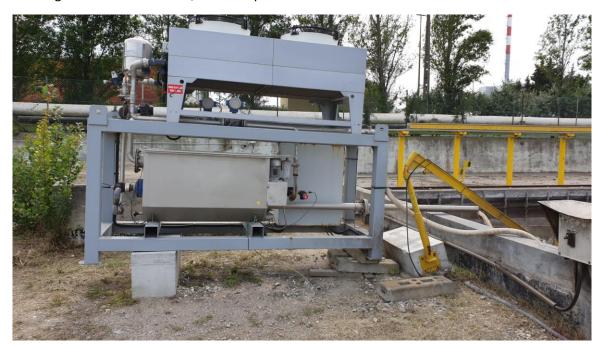
Nevertheless a second collision occurred, again without affecting functionality of the skid, but deforming mechanical elements, which required to be fixed. And the unit re-collocated.

Figure 38. Skid after second collision.

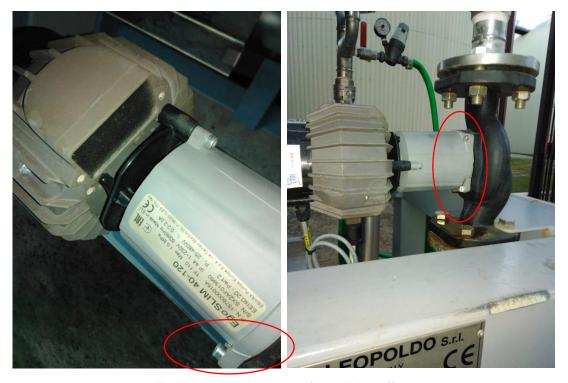
Similar event of collision, but for undetected causes happened in Madrid at WWTP, where clean water circulation pump suffered a fatal damage for collision, which broke the case holding electric motor over pump body, as it can be seen in below image.

Figure 39. Brocken pump for collision effect.
